Manhole Inspection Summary

Manhole # S19I1_021MH

Location Address: **2422 hariett av**

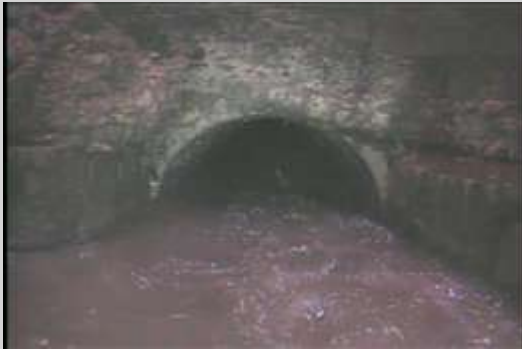
12 O'Clock Outflow

12 in. Circular Gravity Sewer
Pipe Out @ 12 O'Clock

Pipe Height: **12** (in.) Rod and Bar (Angled)
Pipe Material: **Clay** ☐ Pipe Lined
Invert Depth: **14.14** (ft.) Flow Characteristics: **Fast**
Deposits: ☒ None ☐ Mud ☐ Sludge ☐ Debris ☐ Grease
Silt Depth: **0** (in.) Deposits Extent:
Infiltration: **None** Pipe Seal Cond: **Unknown**

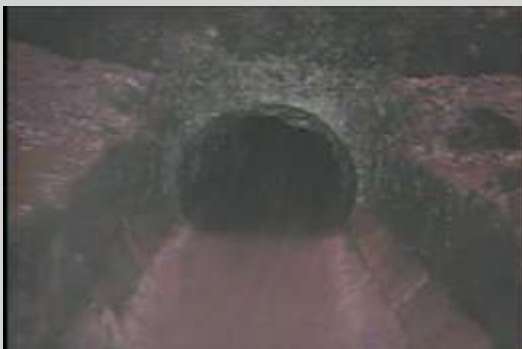
6 O'Clock Inflow

10 in. Circular Gravity Sewer
Pipe In @ 6 O'Clock

Pipe Height: **10.8** (in.) Rod and Bar (Angled)
Pipe Material: **Clay** ☐ Pipe Lined
Invert Depth: **13.93** (ft.) Flow Characteristics: **Slow**
Deposits: ☒ None ☐ Mud ☐ Sludge ☐ Debris ☐ Grease
Silt Depth: **0** (in.) Deposits Extent:
Infiltration: **None** Pipe Seal Cond: **Sound**
